COMPREHENSIVE ASBESTOS/LEAD-BASED PAINT SURVEY

**SINGLE-FAMILY RESIDENCE
1104 FOLLY ROAD
CHARLESTON, SOUTH CAROLINA**

Single-Family Residence
1104 Folly Road
Charleston, South Carolina 29412

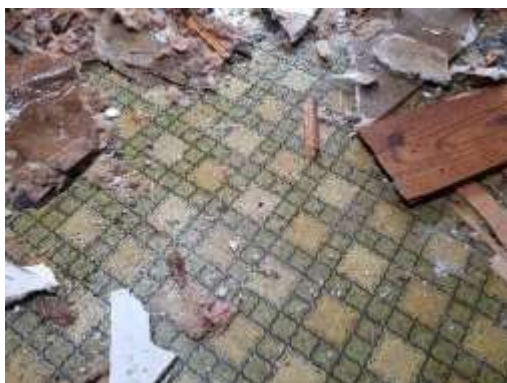
HOMOGENEOUS AREAS 01, 02
VINYL SHEET FLOORING (GREEN/BEIGE)
MASTIC (TAN)

Asbestos fibers were identified in the Vinyl Sheet Flooring (green/beige). Approximately 420 square feet is present and in good condition. This material is considered RACM – Friable Asbestos and is located in the kitchen and the dining room. (layer 1) **Note: Vinyl Sheet flooring may be located under cabinets and walls.**

The ACBM to include the item(s) listed above. All removal work of the identified ACBM should be performed by a properly trained and licensed abatement contractor prior to the planned renovation/demolition activities.

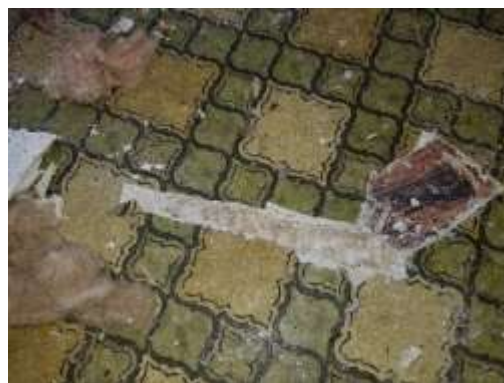
HOMOGENEOUS AREAS 03, 04
VINYL SHEET FLOORING (BEIGE/TAN)
MASTIC (BROWN)

Asbestos fibers were identified in the Vinyl Sheet Flooring (beige/tan). Approximately 420 square feet is present and in good condition. This material is considered RACM – Friable Asbestos and is located in the kitchen and the dining room. (layer 2) **Note: Vinyl Sheet flooring may be located under cabinets and walls.**

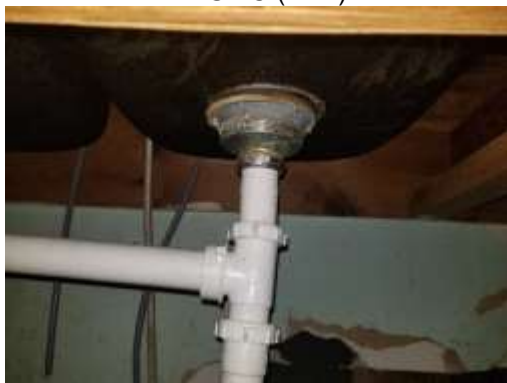
HOMOGENEOUS AREA 05
SINK COATING (BLACK)

Asbestos fibers were identified in the Sink Coating (black). Approximately 4 square feet is present and in good condition. This material is considered Category I – Non Friable Asbestos and is located in the kitchen.

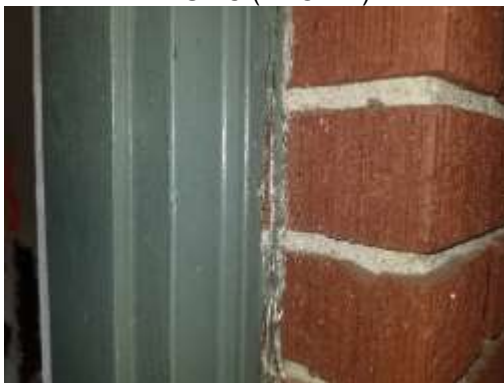
HOMOGENEOUS AREA 06
EXTERIOR CAULK

Asbestos fibers were identified in the Exterior Caulk. Approximately 50 square feet is present and in good condition. This material is considered RACM – Friable Asbestos and is located on the exterior windows and doors.

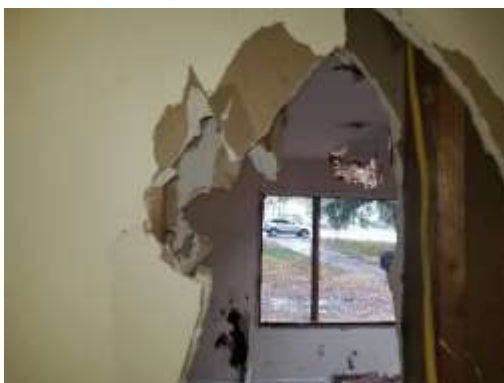
HOMOGENEOUS AREA 09
DRYWALL

Asbestos fibers were identified in the Drywall/Joint Compound. Approximately 5,568 square feet is present and in significantly damaged condition. This material is considered RACM – Friable Asbestos and is located on walls and ceilings.

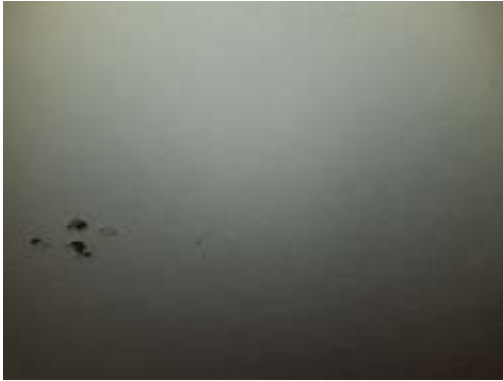
HOMOGENEOUS AREA 10
CEILING TEXTURE

Asbestos fibers were identified in the Ceiling Texture. Approximately 1,392 square feet is present and in significantly damaged condition. This material is considered RACM – Friable Asbestos and is located on the ceilings.

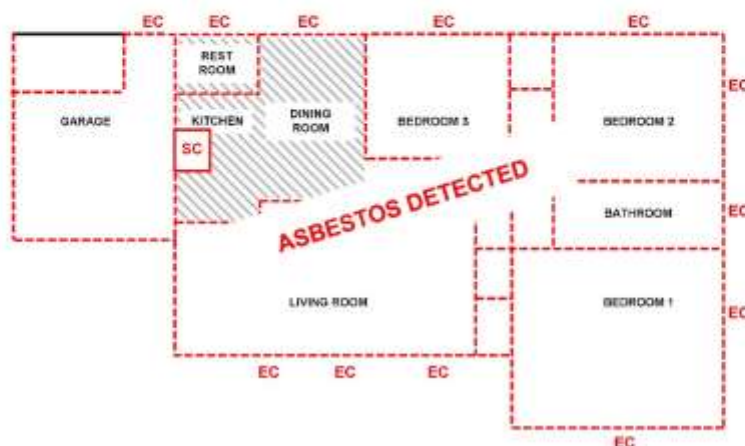
DIAGRAM 1:
 LOCATION OF ACM

- FRIABLE ACM VINYL SHEET FLOORING (GREEN/BEIGE) AND FRIABLE ACM VINYL SHEET FLOORING (BEIGE/TAN) IS LOCATED IN THE KITCHEN, DINING ROOM AND RESTROOM.
- FRIABLE ACM DRYWALL/JOINT COMPOUND IS LOCATED IN THE BUILDING ON THE WALLS AND CEILINGS.
- FRIABLE ACM EXTERIOR CAULK IS LOCATED ON EXTERIOR WINDOWS AND DOORS.
- NON FRIABLE ACM SINK COATING (BLACK) IS LOCATED IN THE KITCHEN.

**FRIABLE CEILING TEXTURE IS LOCATED ON THE CEILINGS
