COMPREHENSIVE ASBESTOS/LEAD-BASED PAINT SURVEY

SINGLE-FAMILY RESIDENCE 1108 FOLLY ROAD CHARLESTON, SOUTH CAROLINA

Single-Family Residence 1108 Folly Road Charleston, South Carolina 29412

Comprehensive Asbestos/Lead-Based Paint Survey Single-Family Residence 1108 Folly Road – Charleston, SC Survey Date: February 11, 2019

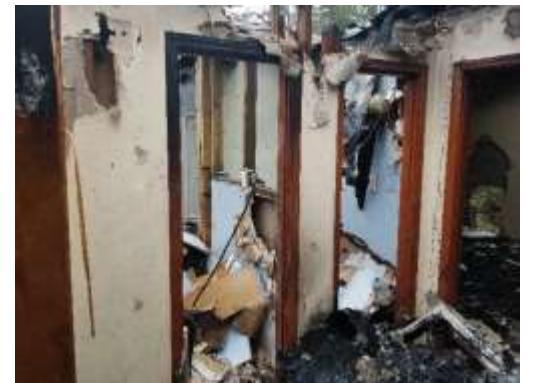
HOMOGENEOUS AREA 04 DRYWALL

Asbestos fibers were identified in the Drywall/Joint Compound. Approximately 8,108 square feet is present and in significantly damaged condition. This material is considered RACM – Friable Asbestos and is located on walls and ceilings.

The identified ACBM includes the item(s) listed above. All removal work of the identified ACBM should be performed by a properly trained and licensed abatement contractor prior to the planned renovation/demolition activities.

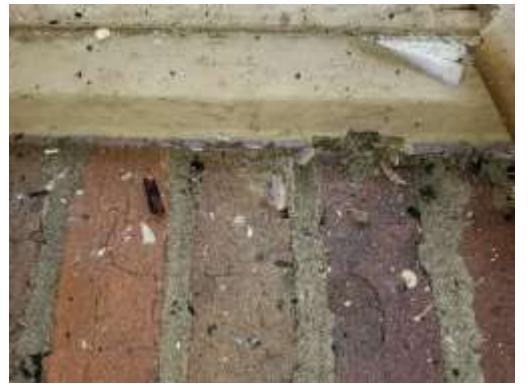
HOMOGENEOUS AREA 06 EXTERIOR CAULK

Asbestos fibers were identified in the Exterior Caulk. Approximately 47 square feet is present and in significantly damaged condition. This material is considered RACM – Friable Asbestos and is located around exterior windows and doors.
